# **ASHRAE Level 1 Energy Audit Report**

## **St. James of Jerusalem Episcopal Church**

220 West Penn Street, Long Beach, NY 11561

**By Philip Jones**  
**October 4, 2021**

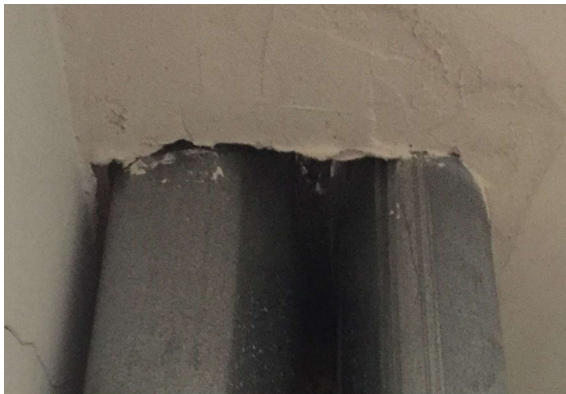
Typical buildings have enough holes to be the equivalent of a full size window which remains open through winter and summer. The St. James church and rectory are not exceptions.

Air conditioning duct in 2<sup>nd</sup> floor of rectory going to attic

It is important that the air sealing be addressed before the insulation is installed when it is easier to locate and does not get masked by insulation that is only doing a portion of the air sealing role. If air sealing is not done, then the effectiveness of the insulation will be diminished. The most critical air sealing prior to insulation application is where there are wall penetrations and gaps at building joints. This air sealing will reduce the preparation and mess with any blown in insulation.

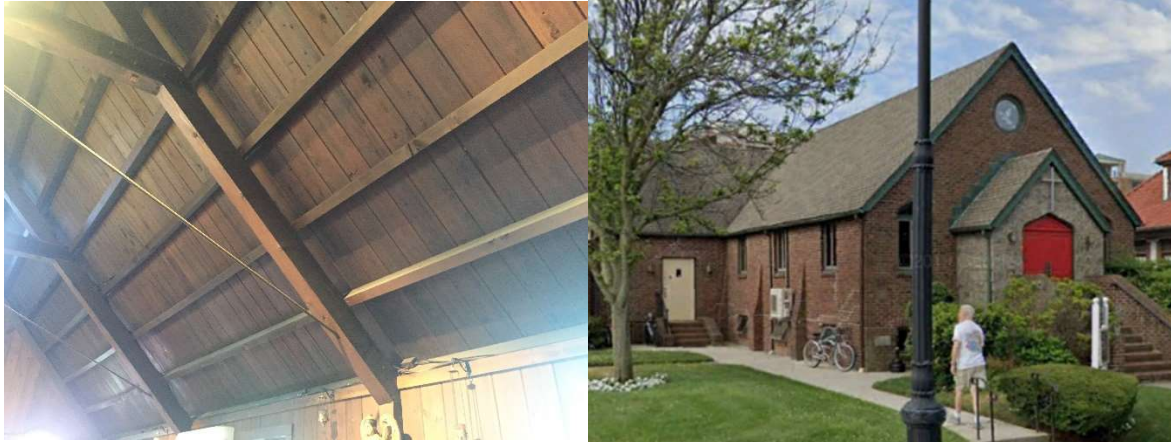
The church roof is the most difficult to insulate in order to maintain both structural integrity and aesthetics. There are two approaches: insulate below the ceiling boards; or insulate under the roof. Under the roof is the ideal location to insulate because a continuous layer can be added without interruptions for beams. However, adding that insulation requires re-roofing the church, which is a significant expense and disruption. If the current roof were in poor shape, then this would be an excellent joint project to add the insulation and replace the roof. Adding insulation and replacing a sound roof is more controversial. However, adding insulation and replacing the roof is probably less costly than the detail work required for insulating from the inside, which would also be aesthetically controversial (but actually could be a good excuse for making a lighter colored ceiling, which would take less energy to light and might be more aesthetically pleasing). Insulating from the inside is discontinuous, with gaps for every horizontal structural beam where a thermal bridge between the outside and the inside reduces the effectiveness of the insulation; so it will be a little less effective.

Adding insulation to the outside consists of adding sheets of foam board (ideally 4 inches) over the ceiling boards, adding another layer of plywood to hold the new shingles, and adding roofing paper (this is trending towards Tyvek®-type breathable roofing paper), and then the shingles. Fasteners for the outer layer of plywood must be carefully selected to ensure structural integrity of the assembly. If the roof is redone this is also an opportunity to consider two other opportunities: lighter color roofing to reduce heat absorption; and alternate materials, such as metal that are more environmentally-friendly (metal roofs last much longer and the materials are recyclable versus composite shingles, and they absorb less heat). An alternative to the foam board is Structural Integrated Panels (SIP) which are manufactured panels made from outside layers of strand board with foam insulation sandwiched between. The panels have excellent structural properties, form better seams than the foam board and can be purchased in variety of thicknesses to obtain the desired level of insulation. Unfortunately, they are also expensive and have long lead times.

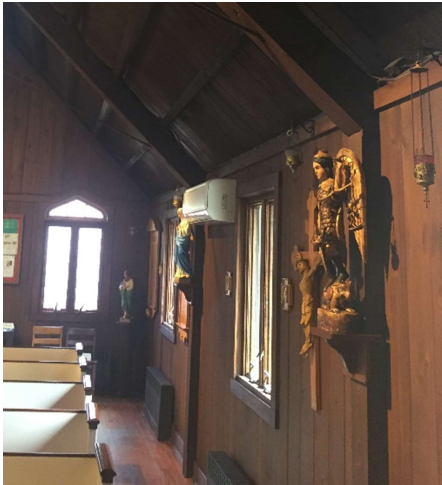
The church and rectory walls have no insulation. There is an air cavity where insulation can be blown-in. In both cases, cellulose would be the best environmental, cost-effective, and insulation-effective choice. The only downside is that it would be ruined in the event of flooding. Spray foam would be the more resilient solution at the expense of the environment and cost.

Church interior wall (left).

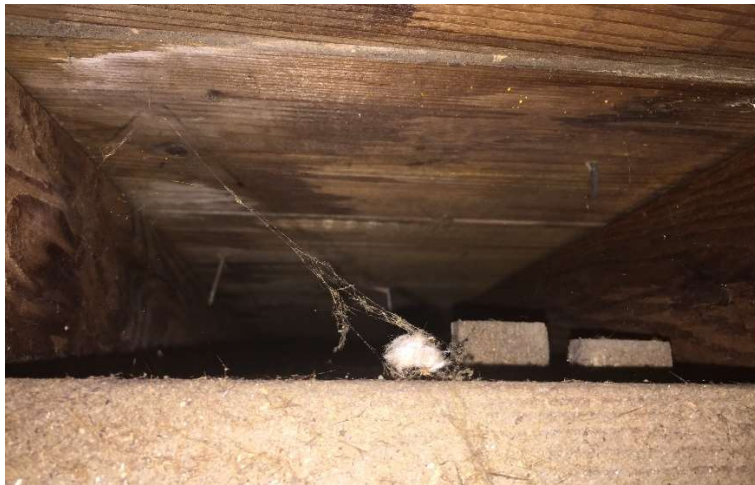
Rectory wall cavity as seen from attic in rectory

For the rectory, the best access is from the attic, which avoids drilling into the walls. Some or all of the wall cavities have horizontal cross beams (which they should have for fire code) and will require inside drilling below those cross beams to blow in the insulation. Basement access may be helpful; so the walls should be insulated before the rim joist is insulated.

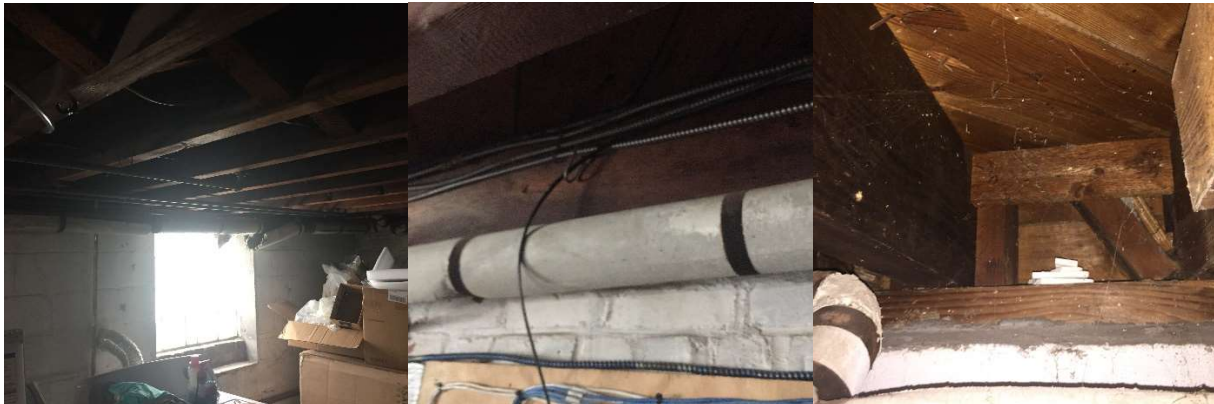
The rectory sits on a flooring system that rests on the basement concrete walls with perimeter beams called rim joists. This area is often left uninsulated and often is not well air sealed. Complete basement insulation should include the rim joist, using either spray foam or foam board pressed into the joist pocket and caulked. Since the basement is below ground and the rim joist is above ground and of a location that is frequently penetrated with utility wires, pipes, etc., it is actually the most important part of the basement to insulate. Towards the bottom of the basement wall has diminishing insulation value due to the relatively constant temperature of the earth.

1) Rectory basement showing joists where they meet foundation wall;2) last joist on the end, running along foundation; 3) rim joint pocket between joists at wall (concrete basement wall at bottom)

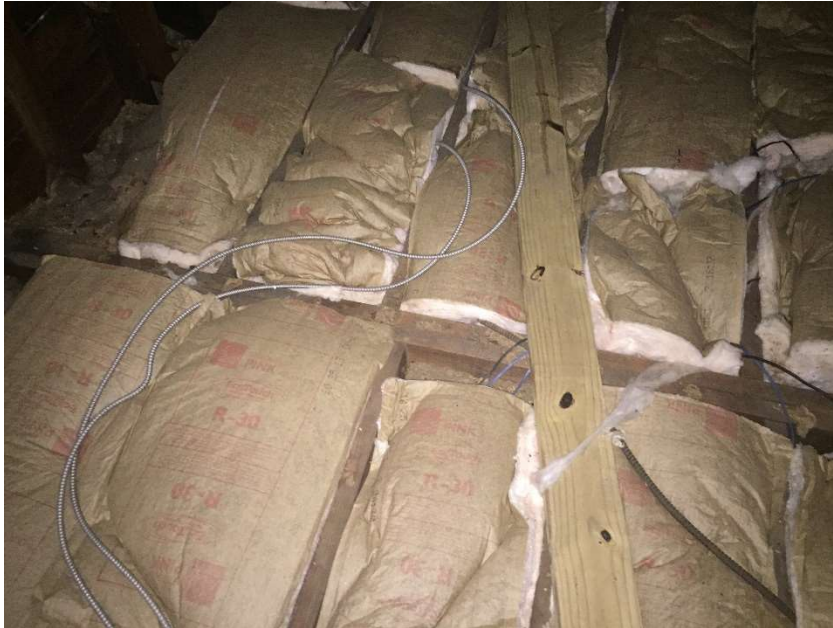
The rectory ceiling has R30 fiberglass batt insulation. The insulation itself is in functional condition, but it is "faced" insulation, with integral tar paper on one side. Faced insulation is not appropriate for attics (or really anywhere else) because it blocks water vapor from escaping through the ceiling. The vapor barrier needs to be at the ceiling (by carefully sealing all wiring penetrations, duct penetrations, etc. and maintaining a continuous painted surface) and any vapor getting through the ceiling needs to be released. The facing acts as a condensation plane, trapping the moisture next to the joists and the ceiling. This facing can be carefully peeled to minimize insulation loss, which is the first step to the next,

which is to better fit the insulation to ensure all cavities are snugly filled and the remaining 3 inches extend above the joists without compacting. The uncovered joists should then be covered with R13 batt insulation cut into 2" strips so there is a continuous insulation blanket across the ceiling. Blocks at less than two foot intervals need to support a pair of 8 inch access planks (similar to shown below) for service personnel to walk on to get to the air handler located in the attic without stepping on the insulation and breaking through the ceiling. The goal is a continuous insulation blanket with a safe clear service path. This insulation work should be done after the walls of the rectory are insulated unless wall insulation does not end up requiring attic access to the walls.

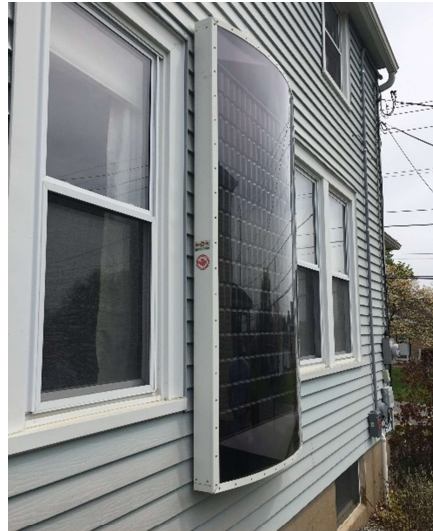
For supplemental space heating, there is a product from Canada called CanSolAir. This device has a solar collector size panel that is mounted vertically on the wall of a building to warm the air in a room. It has an inlet duct at the bottom that comes through the wall of a room and an upper duct that discharges warm air when the duct is open. The system uses a fan to distribute the heat room-wide (system shown is in Nazareth, PA). This panel needs to be located on the south side or back of the rectory and/or church. It can provide heat throughout the year. Unfortunately, it can only be used as supplementary air, and it varies with weather conditions; so it can't be counted on as a primary heat source.

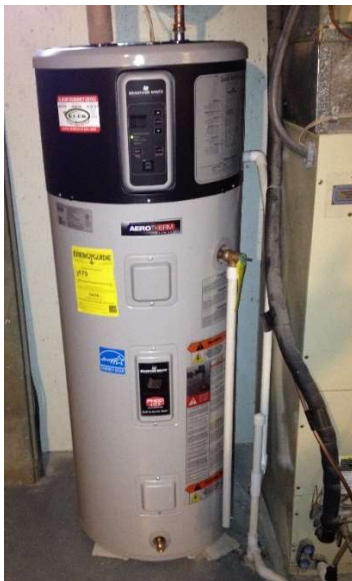
**Heat Pump Water Heater.** Heat pump is black colored area on top (also note, electrical feed is to top, making it somewhat flood resistant, although only part way up. A feature of the heat pump water heater is a control panel which allows for different levels of efficiency versus types of demand and also a “Vacation mode” where the heater relaxes its heating and then ramp back at the end of “vacation.” Vacation mode allows the water heater to be used intermittently to easily schedule to save energy during times of non-use. In some parts of the country, either the heat pump water heater or a substantially more insulated water heater are required in new and replacement situations. This regulation has helped develop the market for these types of products.

Since the rectory uses a 40 gallon tank now, the heat pump water heater can immediately replace the gas water heater.

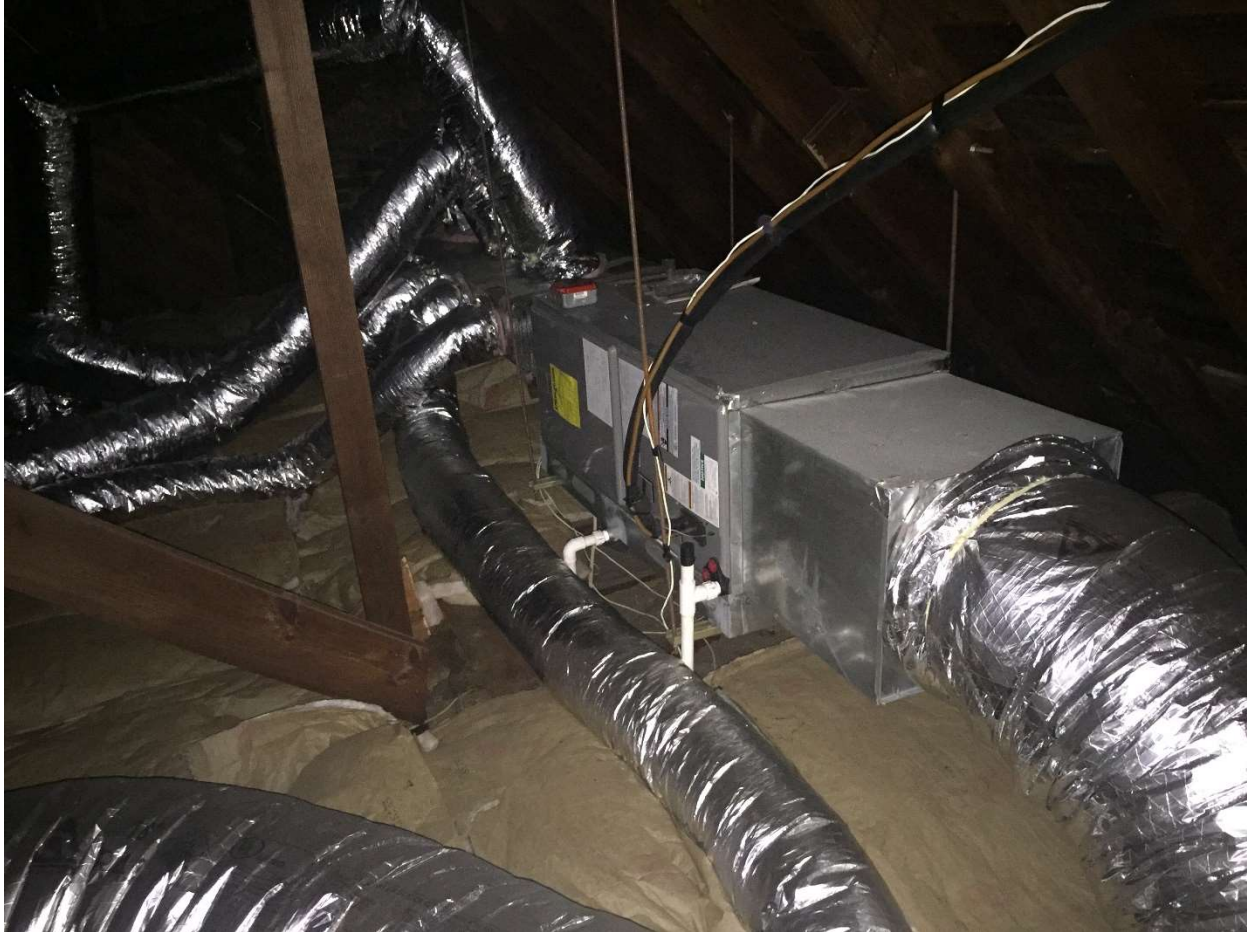
Rectory attic air handler with insulated ductwork serving the second and first floor of the rectory

The 13 SEER rectory air conditioner is on the high end of conventional air conditioners. There are high-efficiency models with two-stage or scroll-type compressors that operate at 16 to 18 SEER. With the migration to non-fossil fuel heating, heat pump options have similar SEER ratings.

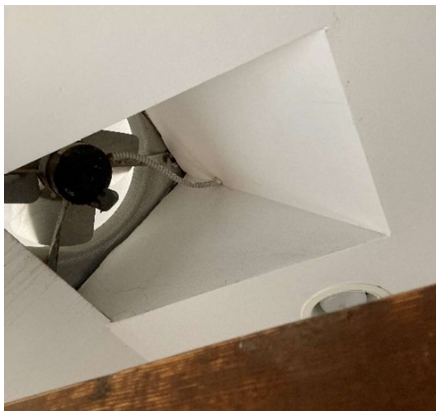
The overcroft has an exhaust fan in the ceiling that was useful prior to the addition of the mini-split air conditioner. Now it is a detriment to keeping this room cool when not in active use as the sole means of cooling this space. It is always a detriment to keeping this space warm.

Overcroft ventilation fan detail and context (courtesy of WC Keller)

To reduce the energy loss from this fan, a swinging door can be made to open against the inside wall of the dormer when using the fan. The swinging door when closed should fit against perimeter molding and have weather stripping to provide an excellent seal when it is closed. The top of the swinging door should have foam board insulation to reduce heat loss through the swinging door when it is closed. The fan can be useful to purge hot air in the office space or for circulation on nice days.

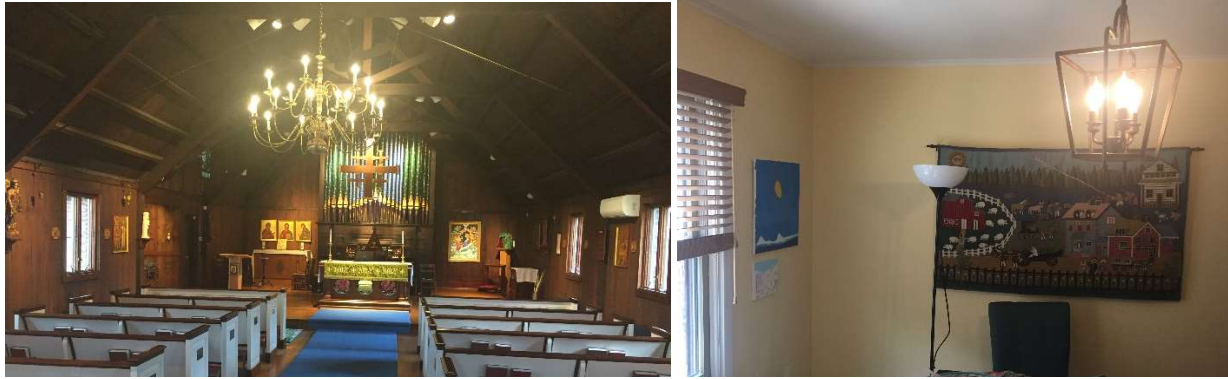
The Sanctuary LED candelabra lights are upwardly directed type lamps, which reduces their illumination below. In the rectory dining room, these candelabra lights are symmetric up and down directed LEDs. Both are the same wattage. St. James caretakers might want to try the rectory dining room lights in the Sanctuary to improve the aesthetics and improve the lighting distribution in the Sanctuary.
