**MASTER PLAN FOR
EFFICIENCY UPGRADES**

ST. JAMES OF JERUSALEM

ENGINEERING REPORT

Master Plan for Efficiency Upgrades
St. James of Jerusalem Episcopal Church
220W Penn St., Long Beach, NY 11561

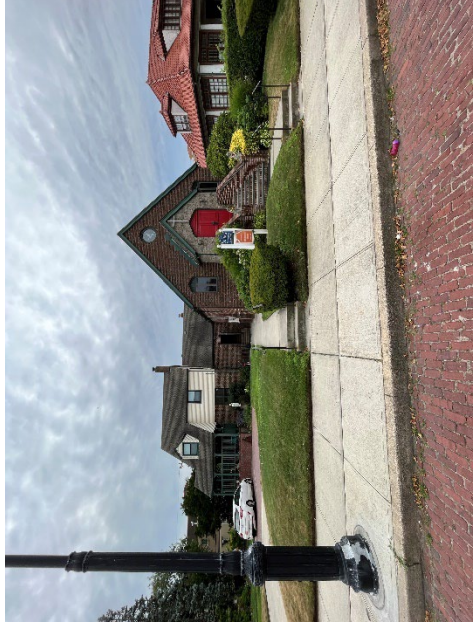
Photo 1: View of the Church and Rectory Building (Building) from West Penn Street.

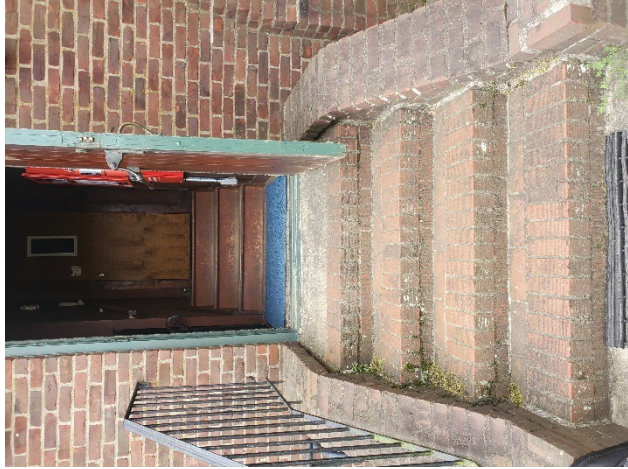
Photo 3: View of the exterior and interior stairs leading to the Church. At the intermediate interior landing, stairs to the left lead down to the Basement.

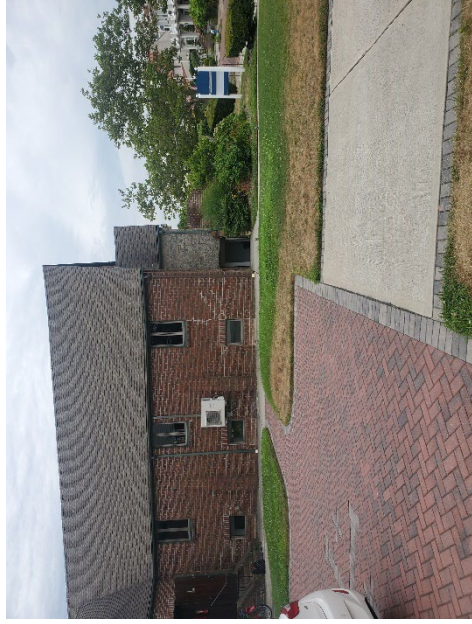
Photo 4: View of the general rise in grade from West Penn Street to the Church entries. The opening at the edge of the Church is an exterior stair down to the Basement. Note the wall-mounted ACCU – it should be raised.

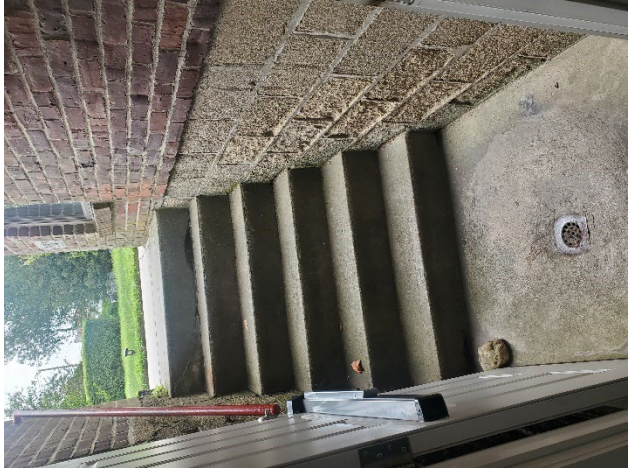
Photo 5: View of the exterior stairs serving the Church Basement. Note the floor drain, which appears to be connected to a dry well.

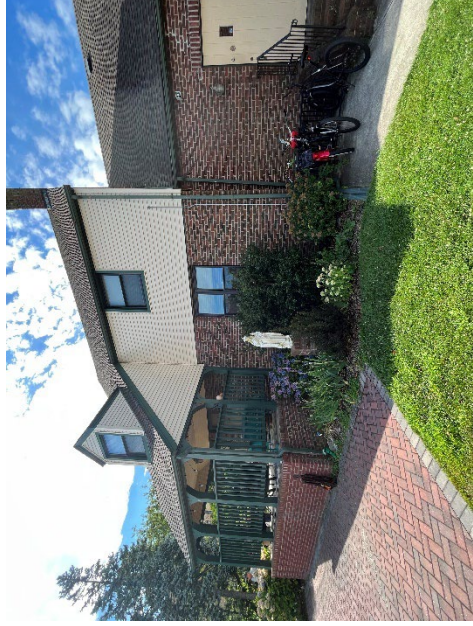
Photo 6: View of the Rectory portion of the Building. Note its elevated front porch.

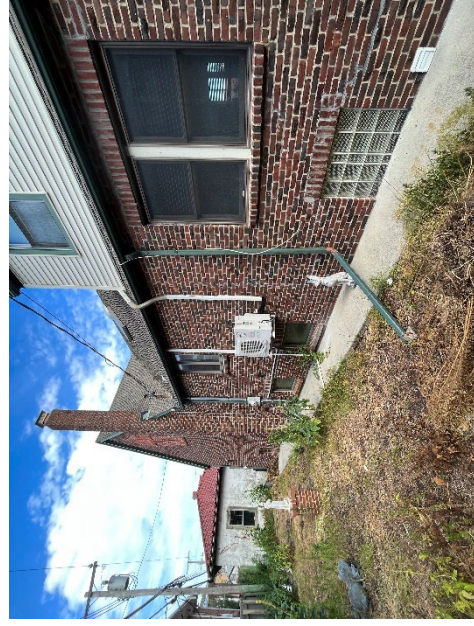
Photo 8: View of the rear of the Building. Note the low windows and vent openings. Note also, the wall-mounted ACCU – it should be raised.

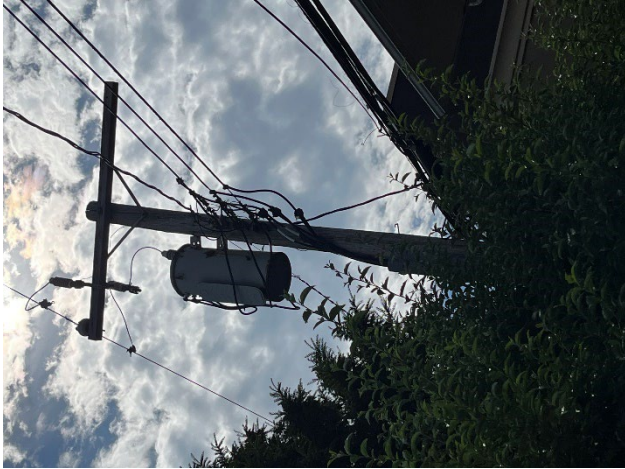
Photo 9: View of the electric service transformer serving the Building and others. This is located near the southeast corner of the Building. The transformer will need to be replaced and upgraded 400A capacity to serve new loads.

- C. Electric Service Capacity:** The existing 200A/120-240V electric service is sufficient for the current loads plus the additional to be imposed by replacing gas stoves and dryers with electric and adding an electric vehicle charging station. The electric service will need to be updated to 400A/120-240V capacity if conversion to all electric HVAC (heat pump) systems is pursued.

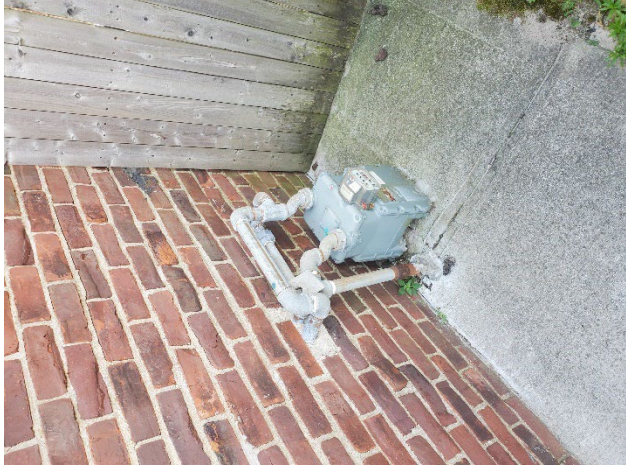
Photo 10: View of the gas meter, which is located at the southwest corner of the Building. If retained, the gas meter should be raised to be 48" above the sidewalk.

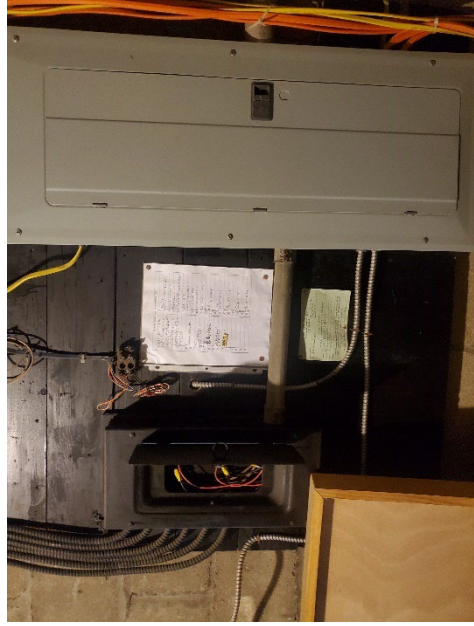
Photo 11: View of the main electric panel, which is located in the Boiler Room of the Church. The incoming service should be located to the 1st Floor of the Church and upgraded to 400A/1-phase capacity.

- D. Electric Panelboard Relocations:** The main electrical panel is currently located in the Basement Boiler Room of the Church. To relocate this panel above the flood elevation it would need to be relocated to the Sacristy. The subpanel for the Rectory is located in its Basement along with telecom panels. To relocate these panels above the flood elevation they would need to be relocated to the First-Floor with the power panel being located in the Rectory Dining Room and the telecom panels being located in the Sacristy. There is also a subpanel in the Church basement Kitchen that should be relocated to the Sacristy.

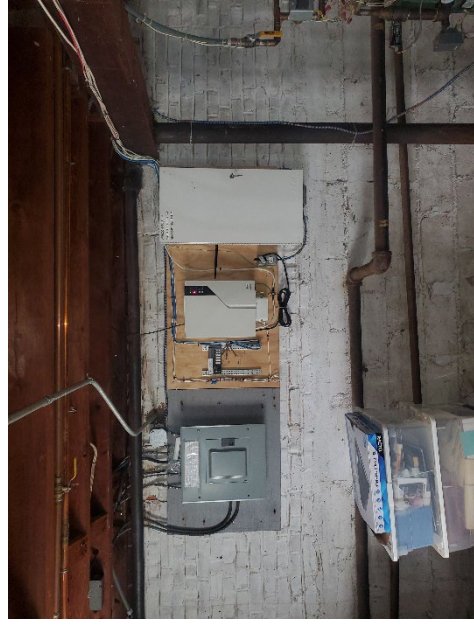
Photo 12: View of the electric subpanel that serves the Rectory portion of the Building and is located in its Basement. Also note the adjacent telecommunications panel. The subpanel should be relocated to the 1st Floor of the Rectory. The telecom equipment should be relocated to the Church due to space considerations.

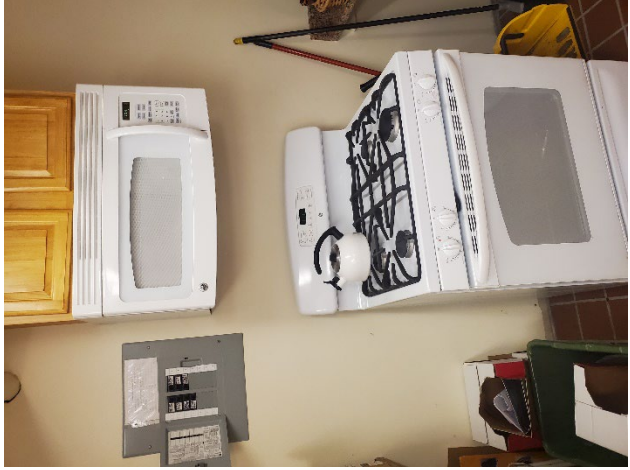
Photo 13: View of an electrical subpanel within the Kitchen area of the Basement of the Church that should be eliminated. Note also the gas stove, which should be replaced with an electric induction type unit.

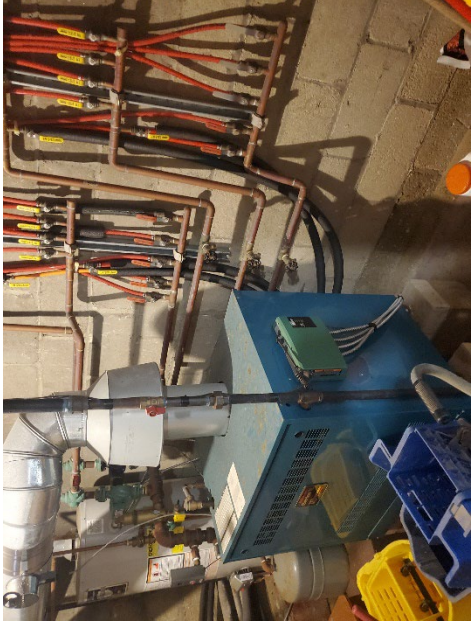
Photo 14: View of the gas-fired boiler, its related piping manifolds, and adjacent domestic water heater that serves the Church portion of the Building and is located in the Basement. Such equipment should be relocated to the 1st Floor

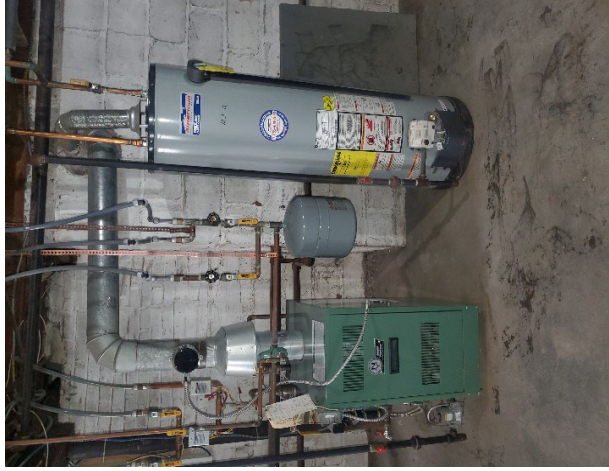
Photo 15: View of the gas-fired boiler and domestic water heater that serve the Rectory portion of the Building and are located in its Basement. This equipment should be eliminated and the loads served by new equipment located above the design flood elevation.

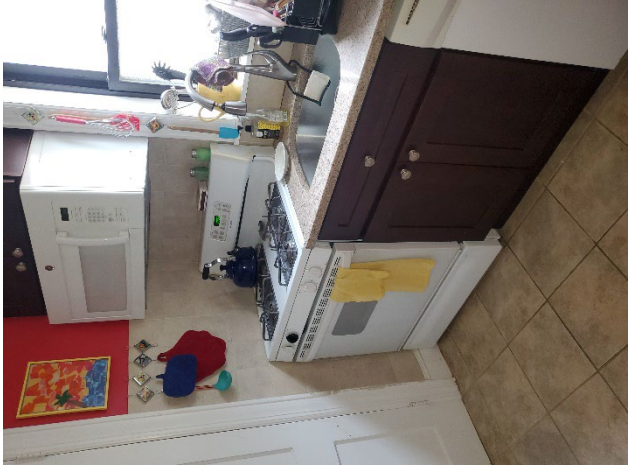
Photo 16: View of the gas stove within the Rectory Kitchen. This unit should be replaced with an electric induction type stove.

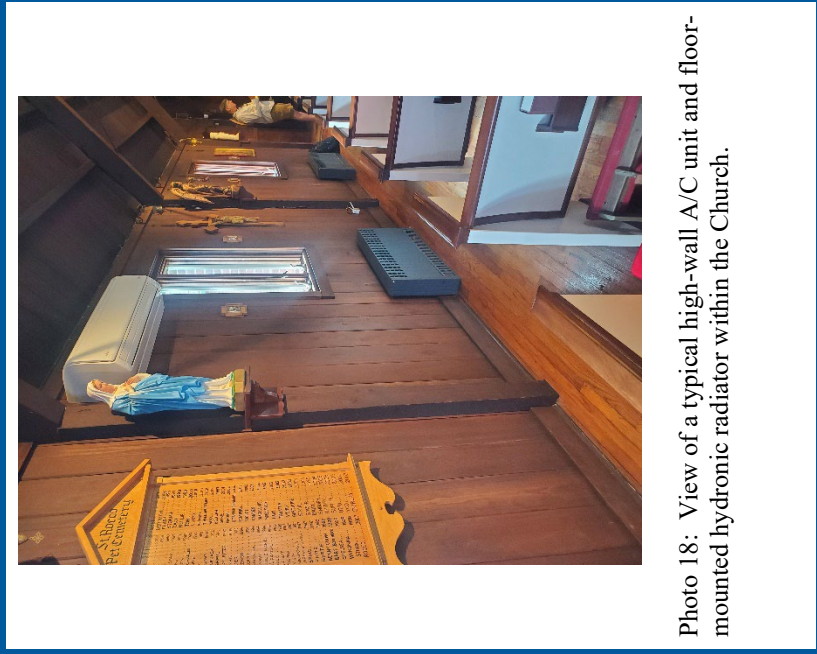
Photo 18: View of a typical high-wall A/C unit and floor-mounted hydronic radiator within the Church.

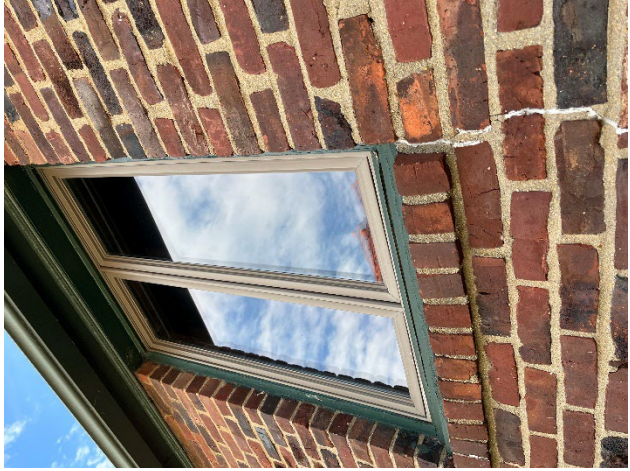
Photo 21: View of the outside of a typical window in the Church. The windows are in good condition.

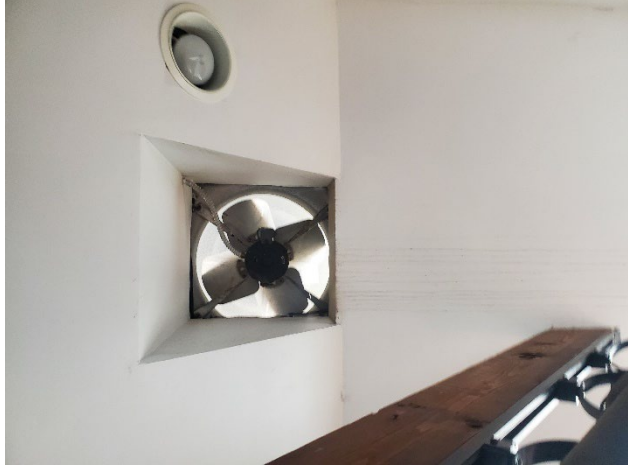
Photo 24: View of an exhaust fan in the Church Overcroft that should be removed and the opening sealed.

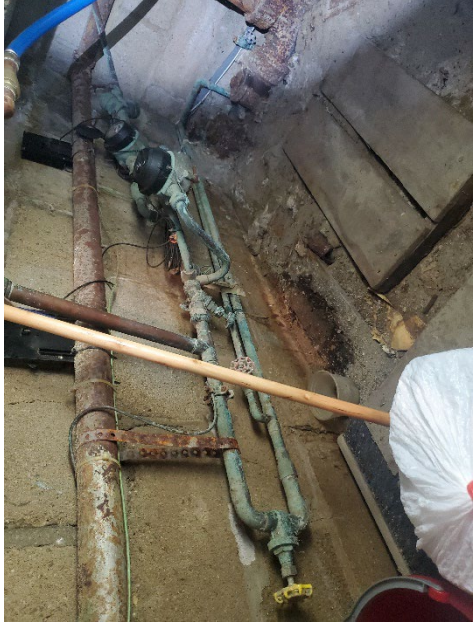
Photo 25: View of the Building's domestic water service which is located beneath the lower intermediate landing of the interior stair. Also note the house trap for the Church in the background.

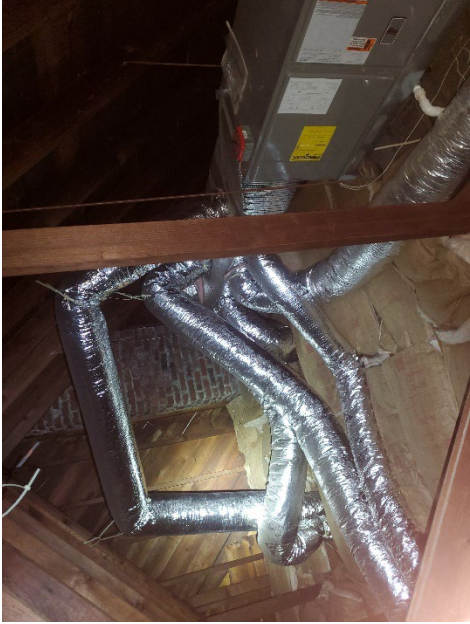
Photo 29: General view of the air conditioning supply ductwork and air handler serving the Rectory and located in its Attic. The unit and ductwork should all be within the insulated envelope or much better insulated.

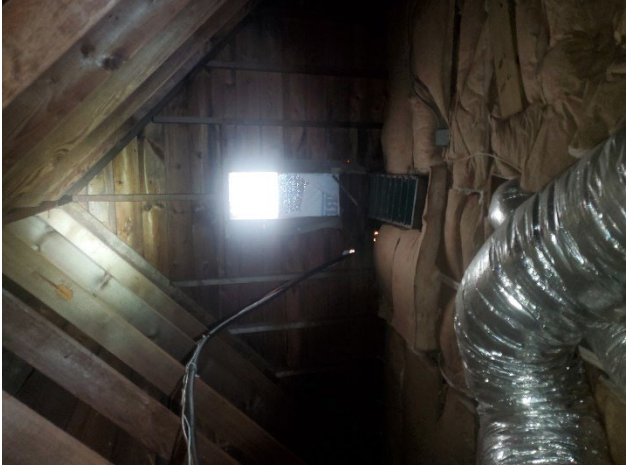
Photo 30: View of the open vent serving the Rectory Attic.

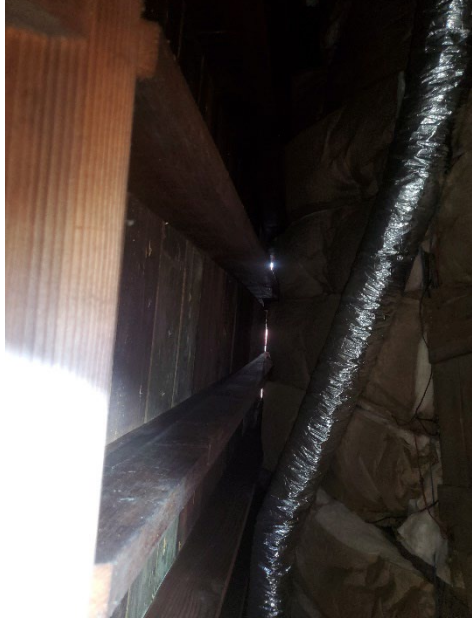
Photo 31: View showing open vents in the roof eaves of the Rectory.

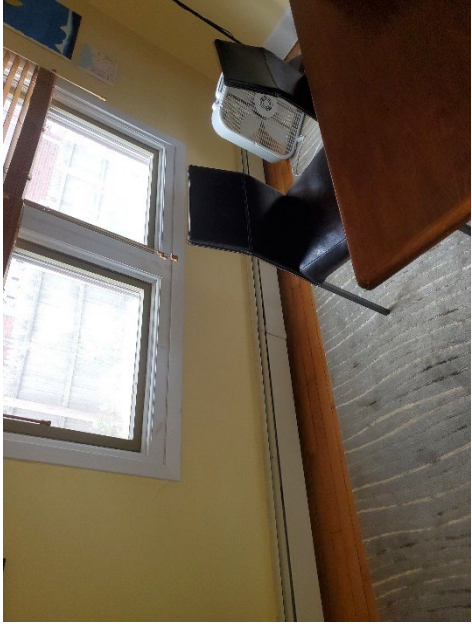
Photo 33: View of typical finned-tube hydronic baseboard used to heat the Rectory.

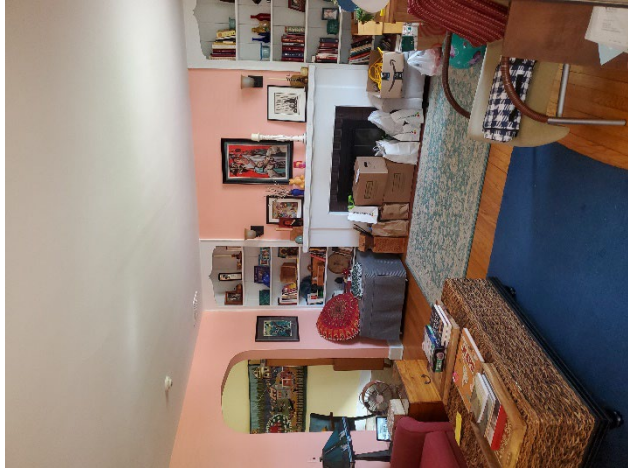
Photo 35: Overall view of the Living Room of the Rectory. Note the single air diffuser and table-mounted fan, which was one of several fans observed throughout.

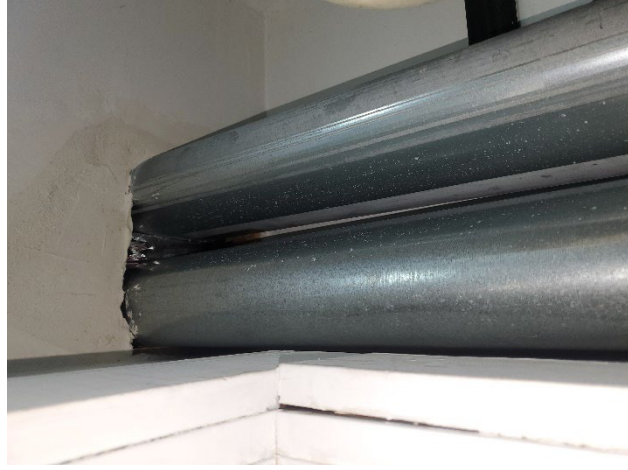
Photo 36: View of duct risers extending down to 1st Floor through a 2nd Floor closet. Note that the opening is unsealed and the ducts uninsulated.

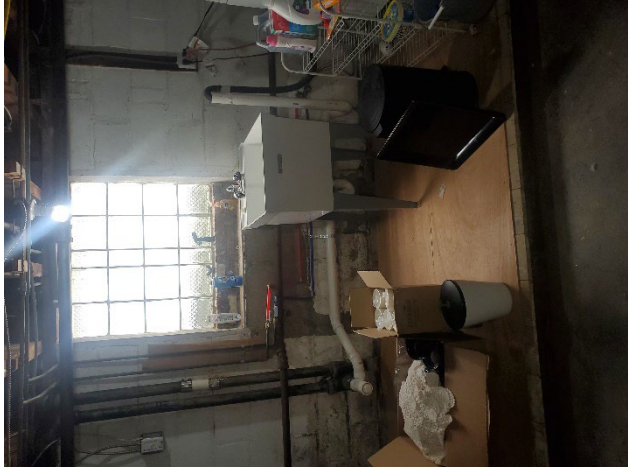
Photo 37: View of the laundry area in the Basement of the Rectory.

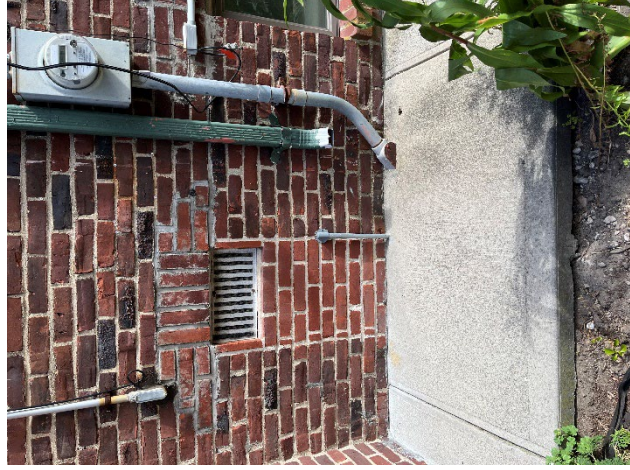
Photo 40: View of the electric meter for the Building. The upgraded replacement should be raised to about 60" above the walkway. Also note the outdoor air intake to the Church Boiler Room referenced in photo 26.
